# **Greater Edwards Aquifer Alliance**

## **Lorence Creek HOA Retrofit Project and Water Quality Assessment**

**(Funded as Lorence Creek Stormwater Retrofit and Research Project under the Proposition 1 Edwards Aquifer Protection Projects within Urbanized Areas of Bexar County)**

January 13, 2023

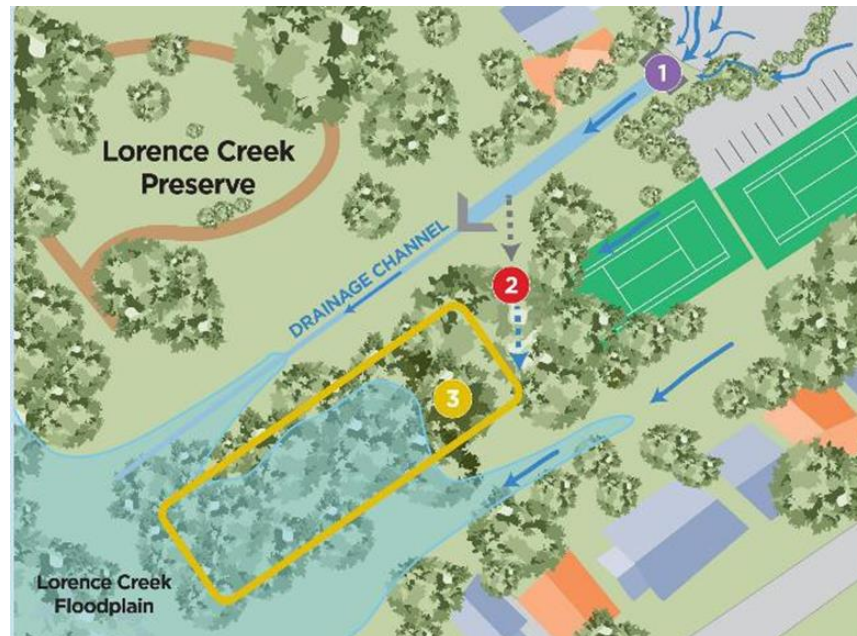
**Figure 2: Lorence Creek HOA LID Retrofit Project Site and Treatment Train Overview**

**SEDIMENT FOREBAY** – collects trash, sediment and organic debris for easy removal and disposal, preventing elevated nutrient levels and avoiding pollution from contaminants that adhere to sediment such as heavy metals.

**BIOINFILTRATION BASIN** – allows a portion of the diverted stormwater to filter through native plants and engineered soil (above a liner). Overflows enter directly into the enhanced natural bioretention area.

**ENHANCED NATURAL BIORETENTION AREA** – completes the stormwater BMPs treatment train, filtering stormwater through a natural system.

The greatest volume of water quality improvement provided by the project was due to directing stormwater runoff into an enhanced natural bioretention area after passing through a series of pre-treatment measures. The volume of the system was calculated in accordance with the San Antonio River Basin Low Impact Development Technical Design Guidance Manual (SARA 2019).

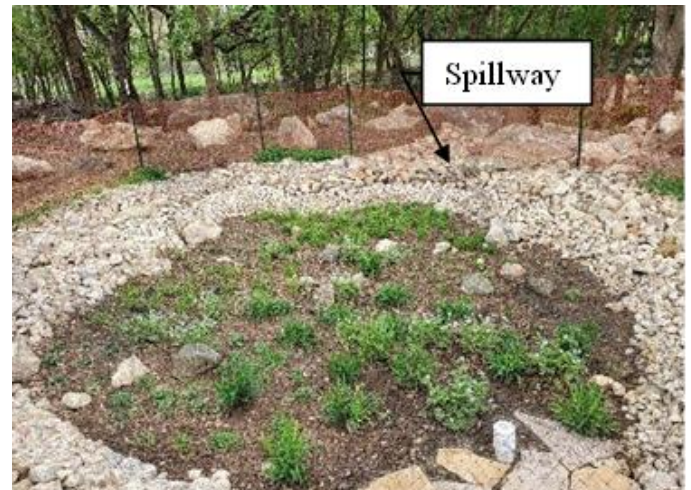
**Figure 6: Completed Basin with Spillway That Overflows into the Enhanced Natural Bioretention Area**

The bioinfiltration basin was then planted with a combination of shade-tolerant perennial and annual plants, such as Inland Seaots, Missouri Violet, and Eastern Gammagrass, that would thrive in both cool and warm seasons, as shown in Figure 6. This combination promotes the system's ability to filter out pollutants year-round. A more detailed plant list can be found in Appendix C of this report

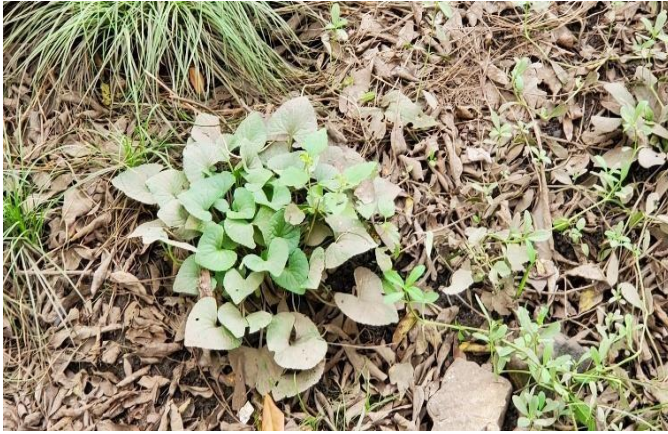
**Figure 7: Sediment Settles on Basin Plants After Rain Event.**

1. During rain events of 0.5 in. or greater, a fine film of sediment would coat the topsides of the plant leaves. An investigation indicated that a source of this sediment was due to the separation of small particles within the engineered soil that was being picked up by the stormwater when the basin fills and resettled on top of the leaves, as shown in Figure 7. This observation was supported as the sediment film did not appear on the vegetation within the bioswale. This issue has been partially remedied by planting plants that grow larger.
2. The bioinfiltration system benefits by allowing some of the organic debris to remain on the surface to: assist in maintaining moisture levels in the media, reduce weeds, maintain organic matter and fertility levels within the media through decomposition, support the media's ability to remove

some pollutants through adsorption and dissipation (Harju, et al. 2021), and reduce maintenance as low levels of sediment are incorporated into media aggregates.

Therefore, for the past 2 years a maintenance strategy has been to allow some organic matter to accumulate, much like that in a natural system. As this material breaks down on the surface, it moves down through the soil profile, promoting plant growth, a robust soil microbial population, soil fertility, aggregate stability, adsorption and dissipation of stormwater pollutants and even carbon sequestration (Sustainable Agriculture Research and Education. 2020). Currently,

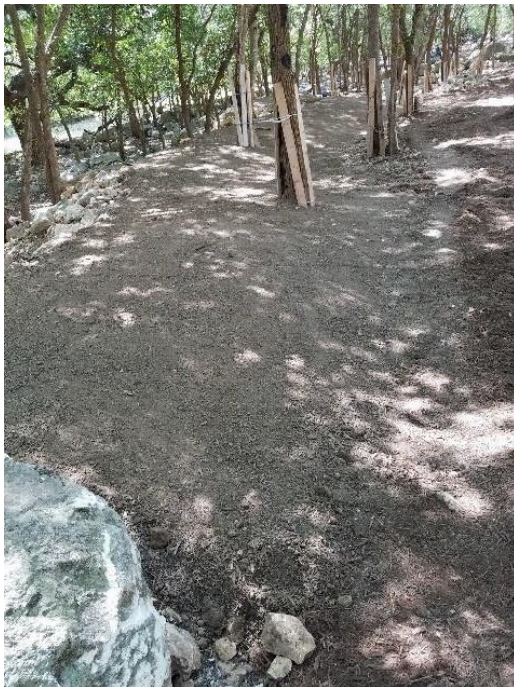
**Figure 8: Completed 3:1 Berm on Northside of Area.**

Tree removal was limited to several under-protected size trees (less than 6 in. diameter) and protection was provided for the remaining trees as seen in Figure 8. On one side of the original natural depression an existing partial low berm was extended by using boulders from the center of the area to create the core of a continuous 3:1 slope berm. The rock core was then covered with a liner that prevented water movement from the

1. Growing conditions consisting of intense shade and shallow (4 in. - 6 in.), poor quality soil and the 2-year plus drought,
2. The 3:1 slope for such conditions proved to be excessively steep; a 4:1 would be recommended,
3. The deer's ability to remove branches and rocks at the top of the berm that interfered with their mobility along the top of the berm, and
4. To a lesser degree, use of the berm area by local youths.

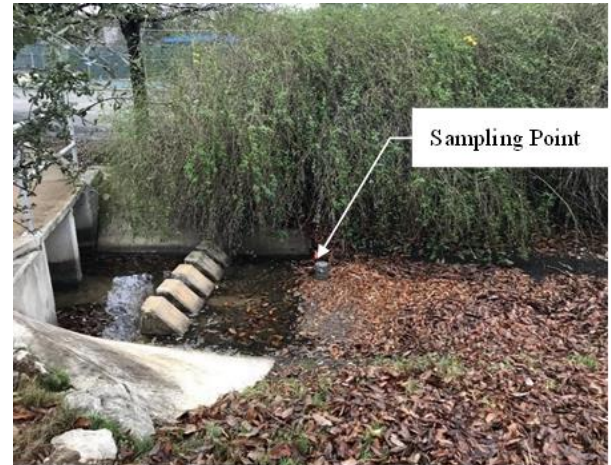
**Figure 11: Inlet Sampling Point for Pre-Construction Soil and Stormwater and Post-Construction Stormwater**

The location for the pre-treatment sample site was again located at the end of the street inlet /interceptor pavement but in front of the sediment forebay. The post-treatment sample was collected at the bioinfiltration discharge outlet where the 4 in. perforated PVC pipe collected the filtered stormwater and discharged outside of the natural bioretention area but within the project site as shown in Figure 12. Post-construction sampling was limited to water quality analyses as there was no soil or sediment at the post-treatment sampling site. By comparing the concentrations of stormwater pollutants at the inlet and outlet and calculating the removal percentage, the pollutant removal efficiency was evaluated for stormwater runoff

1. Pre-treatment point at almost the same pre-construction sampling point shown in Figure 11; at the end of the concrete interceptor and before the sediment forebay, and
2. Post-treatment point at the bioinfiltration basin discharge outlet as indicated in Figure 12.
