# ROOF TOP HARVESTING AND STORMWATER DISPERSEMENT OVER THE EDWARDS AQUIFER RECHARGE ZONE: A RETROFIT FOR TREATMENT OF PREVIOUSLY UN-TREATED IMPERVIOUS COVER

A City of San Antonio, Edwards Aquifer Protection Venue program funded project

FINAL REPORT PREPARED FOR:

BRIAN G. LAUB  
MELISSA GARCIA  
LANI MAY

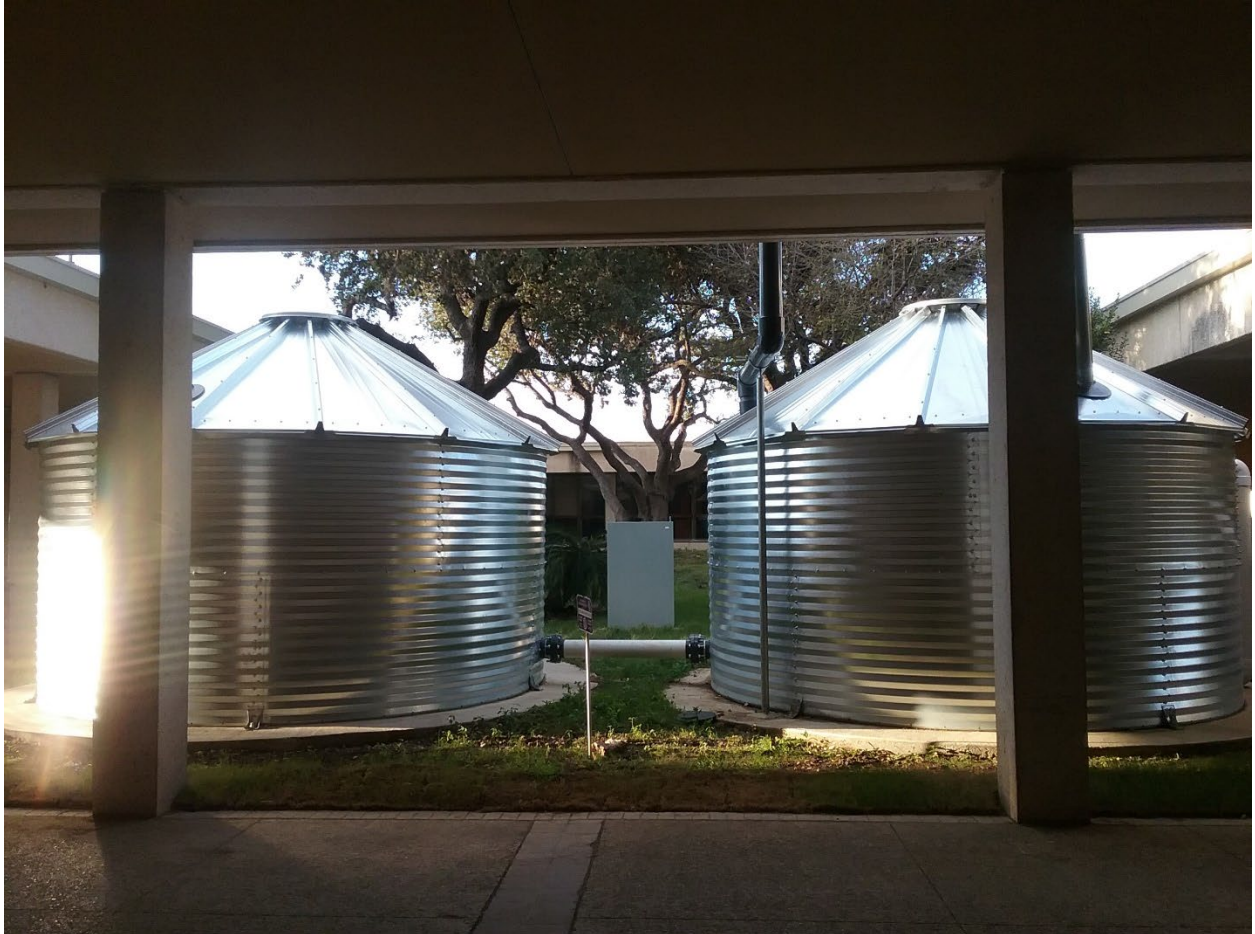
**Figure 2.** *Picture showing the two cisterns in the breezeway between the Convocation Center and Intercollegiate Athletic Building, adjacent to a major walkway through campus.*

Two 9,500 gallon cisterns were placed in an interior breezeway between the Convocation Center and the Intercollegiate Athletic Building (Figure 2). The cisterns capture rooftop runoff from both buildings. The location provided immediate access to rooftop drains and was also in a highly visible location on campus, which promoted informative signs and visibility of the cisterns. Water collected in the cisterns is used to irrigate nearby green spaces. When the cisterns fill, the excess water from rooftop drains flows into sidewalk surface drains and eventually into the bioretention basin.

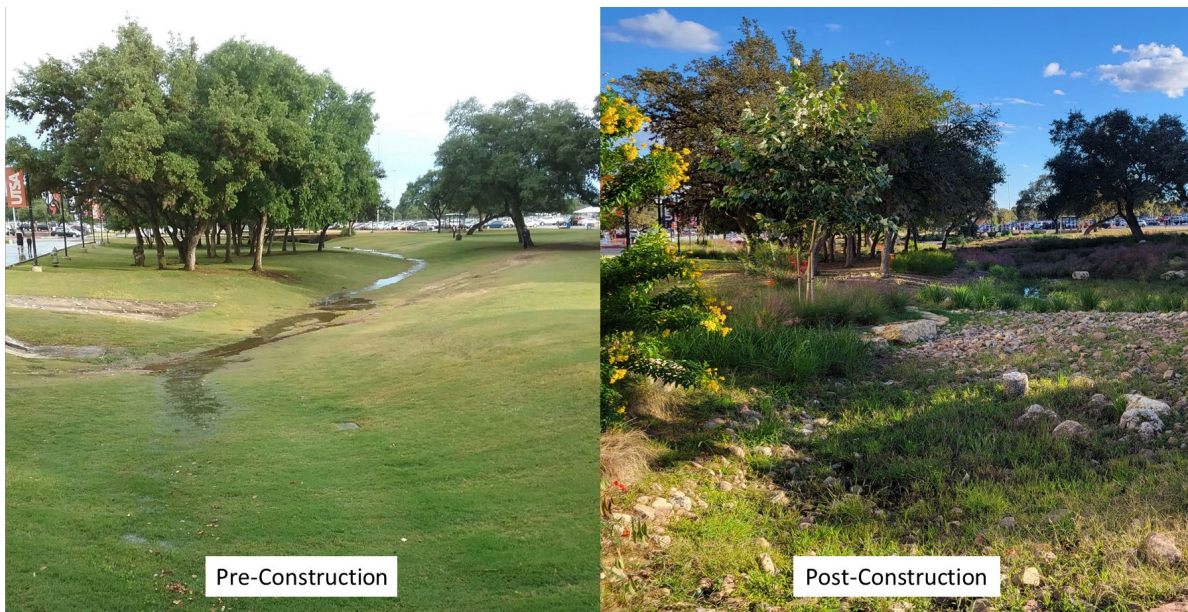
**Figure 4.** Before-after photos looking downstream, showing the mowed channel in the pre-construction condition and the north basin of the bioretention basin two years post-construction.

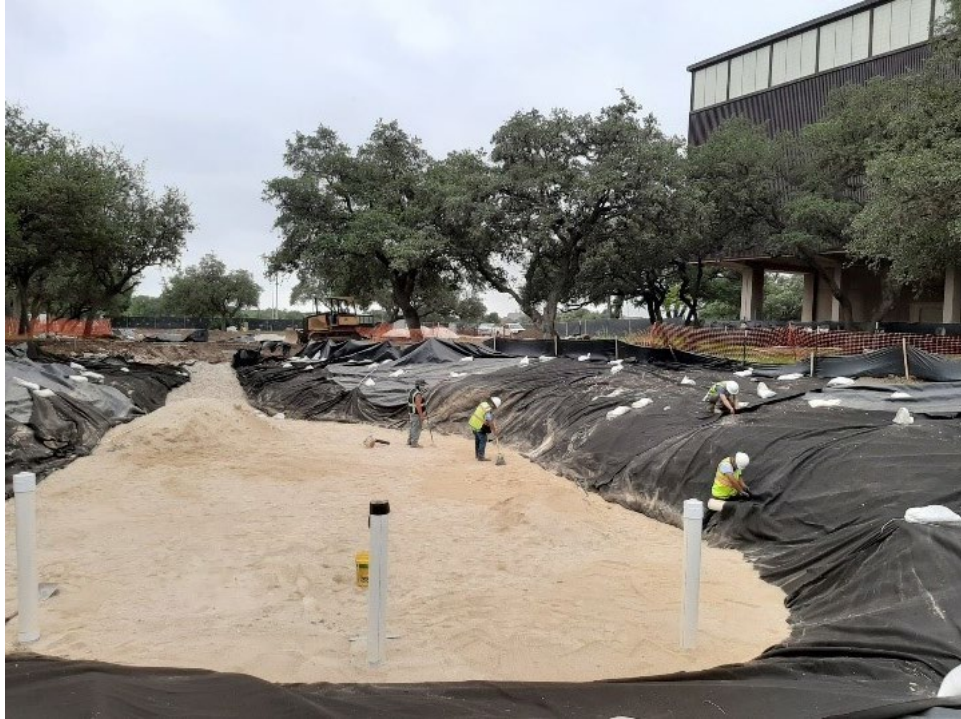
**Figure 5.** Photograph showing the impermeable liner and basin partially filled with sand and biomedix mix.

Construction of the basin followed the San Antonio River Authority (SARA) LID technical design guidance manual (SARA 2019). The excavated basin was lined with an impermeable liner, and perforated pipe was placed in the bottom of the basin to drain water that filtered through the overlying sediment and soil layers (Figure 5). Design documents called for a 1.25-foot layer of 1-inch washed gravel (#57 stone) to be placed on the liner and around the underpiping. Delivered base rock was unwashed, heavily silted, and more chipped than specifications, but was still accepted for use in the basin. Immediately atop the gravel, a barrier layer of 2-inch washed sand media, with grain size distribution comparable to washed concrete sand was applied. A layer of soil biomedix mix, with design specifications of 3-feet minimum depth, consisting of 85-88% washed coarse sand, 8-12% fines passing a #270 sieve, and 2-5% organic matter was placed atop the sand barrier layer. The biomedix mix was tested to determine whether it met design specifications, and several mixes did not meet specifications and were rejected. The process of finding biomedix mix that met design specifications delayed construction progress. The biomedix mix was covered with a 4-inch layer of shredded hardwood mulch. One exception was the forebay, which was lined with cobbles, because the forebay received runoff from the upstream channel as well as the HEB SU, so was an area of high flow energy, and the cobbles were placed to help reduce erosion.

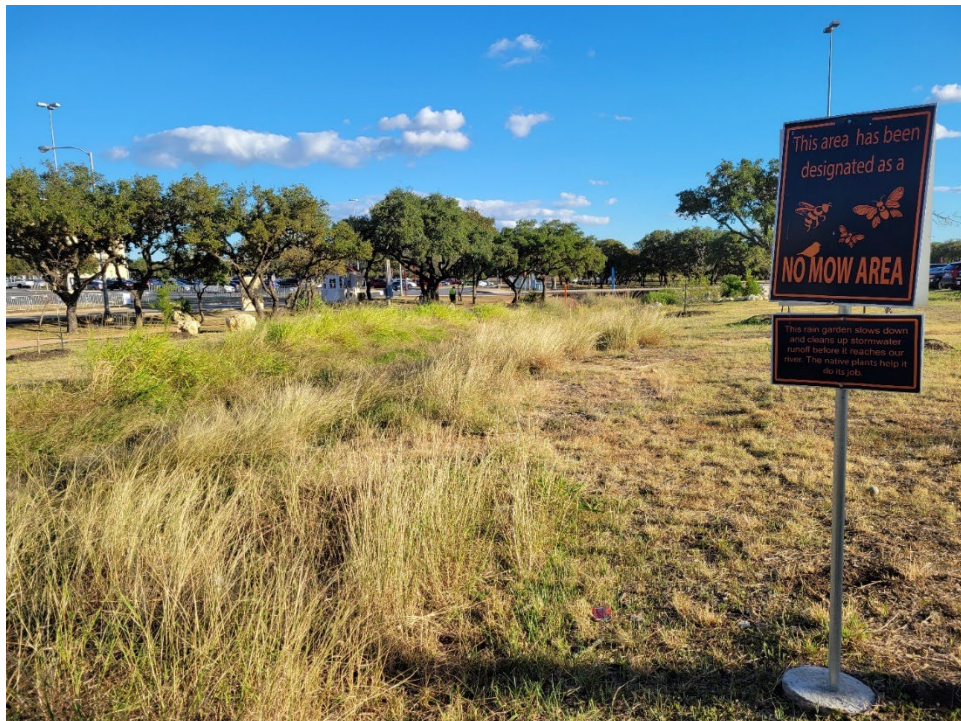
**Figure 6.** Photograph showing the unmowed grassy channel. Picture orientation is looking downstream toward the bioswale.

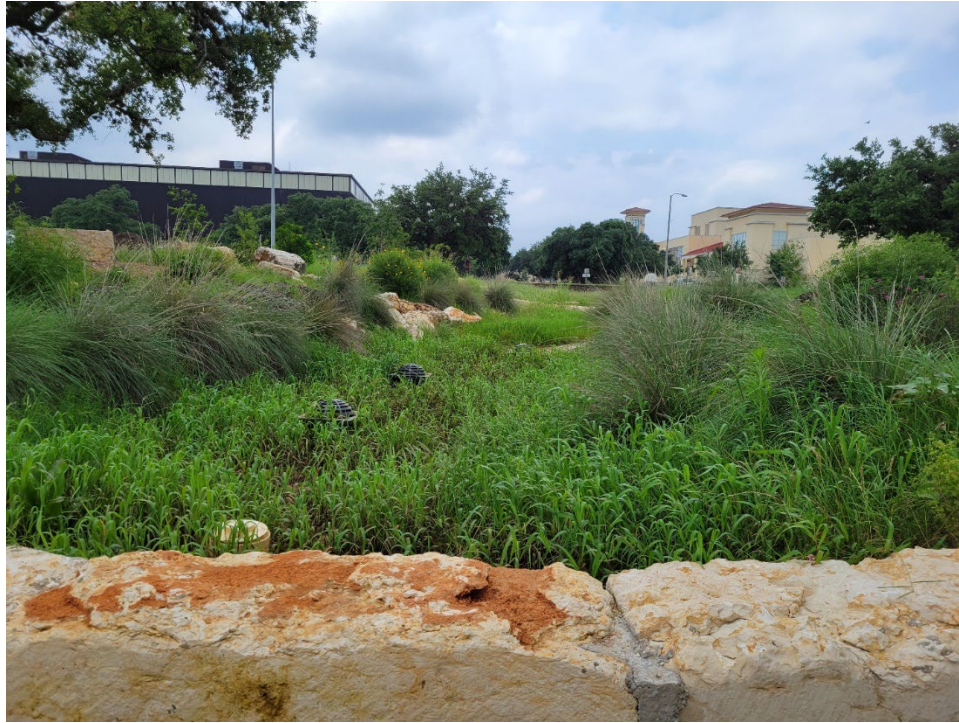
**Figure 7.** Photograph showing the bioswale. Picture orientation is looking upstream toward the unmowed grassy channel and bioretention basin.

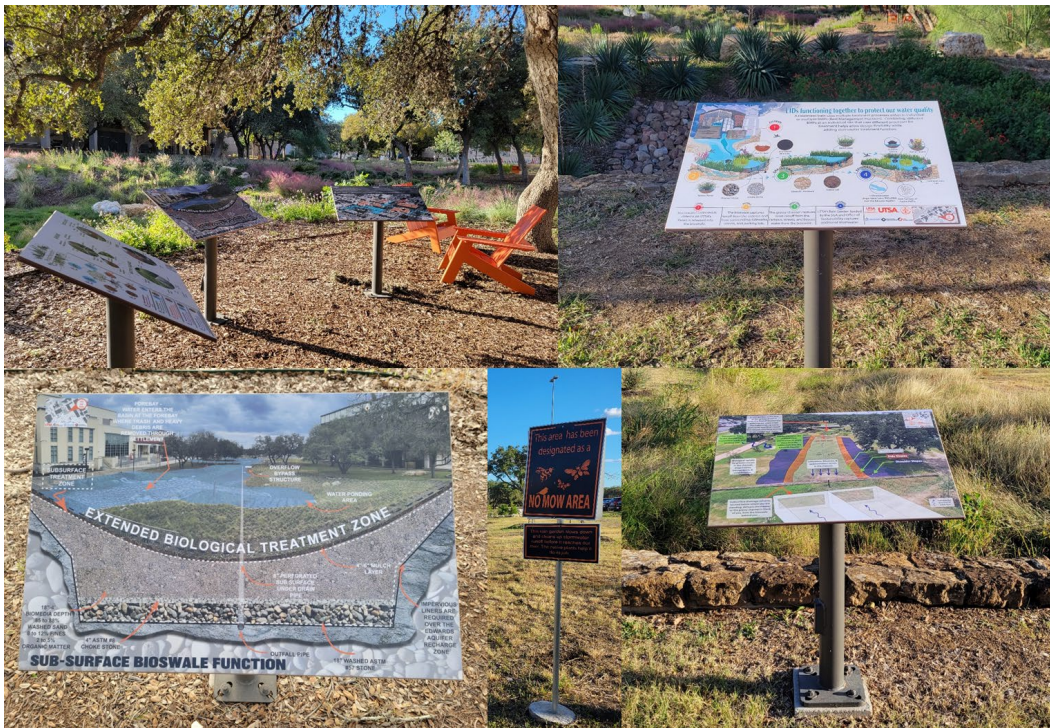
**Figure 8.** Pictures showing several of the information signs posted near the LID facilities. The bottom-left picture shows details of the layers contained in the bioretention basin.

Signs describing the operation and purpose of the cisterns, bioretention basin, and grassy channel and bioswale were placed at several locations (Figure 8). The signs provide students and visitors to campus information about the LID facilities, thus raising awareness about the importance of stormwater management for protecting aquatic resources.

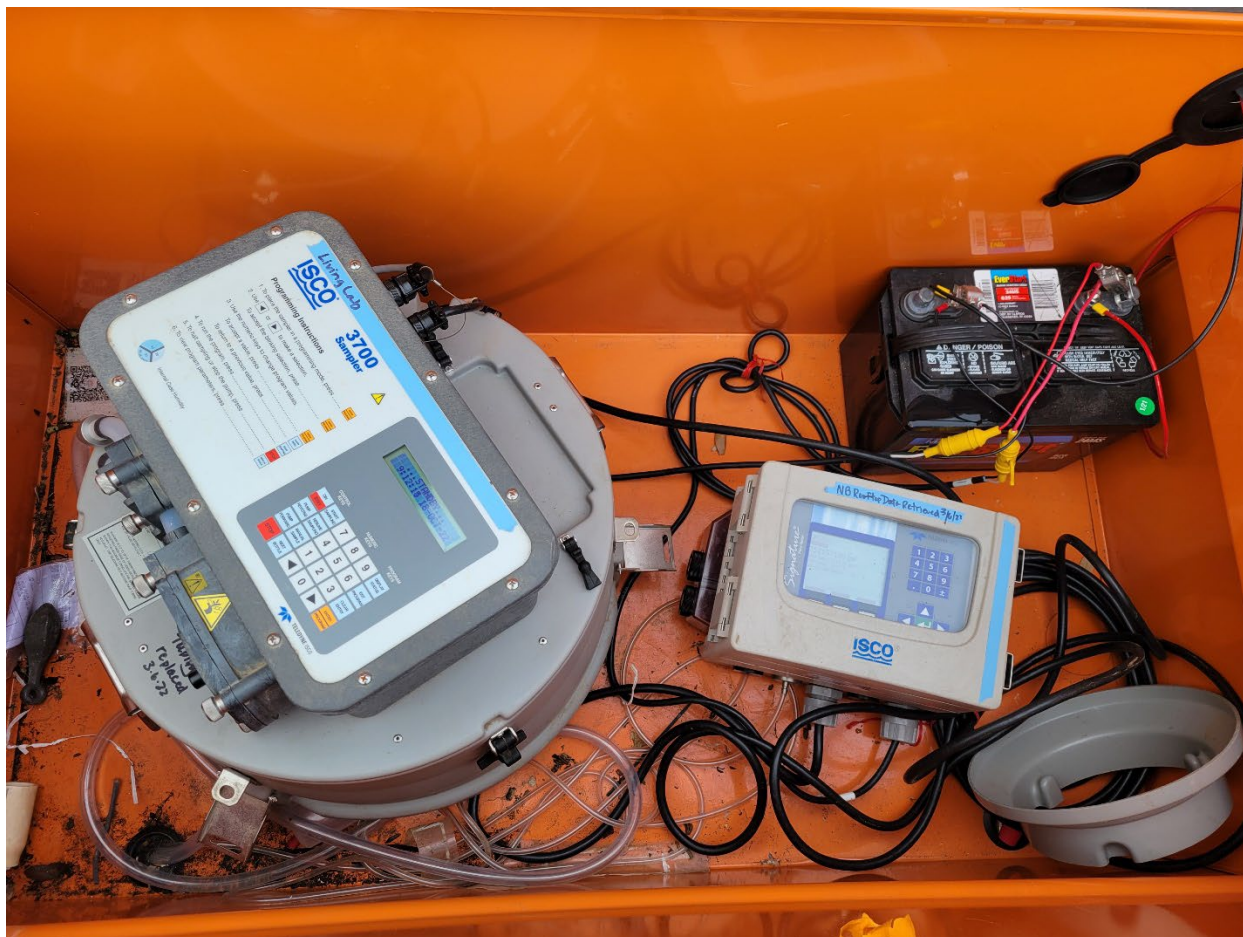
**Figure 10.** Picture of the automatic water sampler on the left and flow meter on the right.

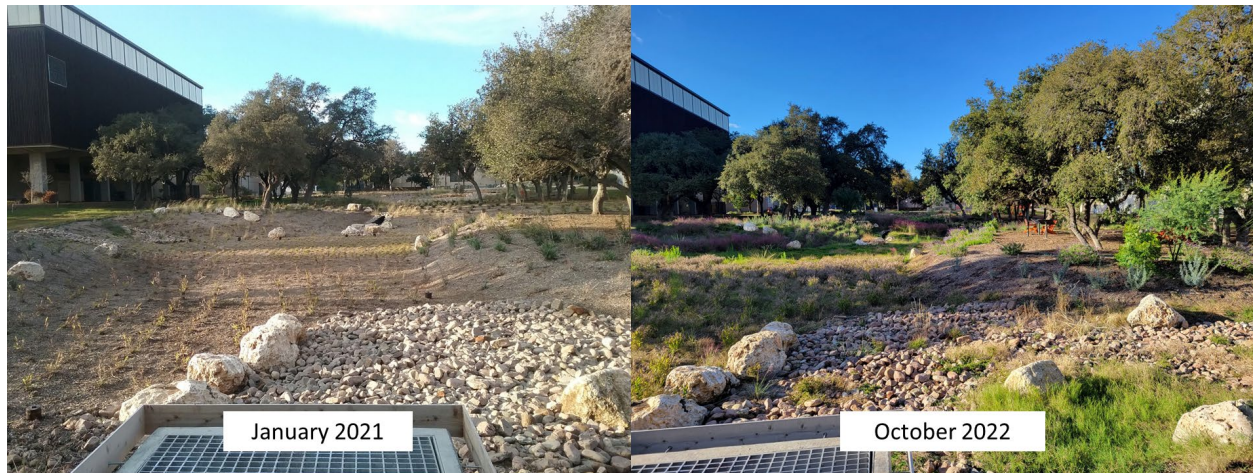
**Figure 15.** Photographs show growth of planted vegetation in the bioretention basin over time. The left photo was taken two months after basin construction, the right photo was taken almost two years after basin construction.
