# EA Project Summaries and Findings Report Project

## Project 7 – Water Quality in the Leon Creek Watershed Recharge Zone as a Function of Urban Development, and Community Education of the Threats and Conservation of the Edwards Aquifer

#### Author: UTSA

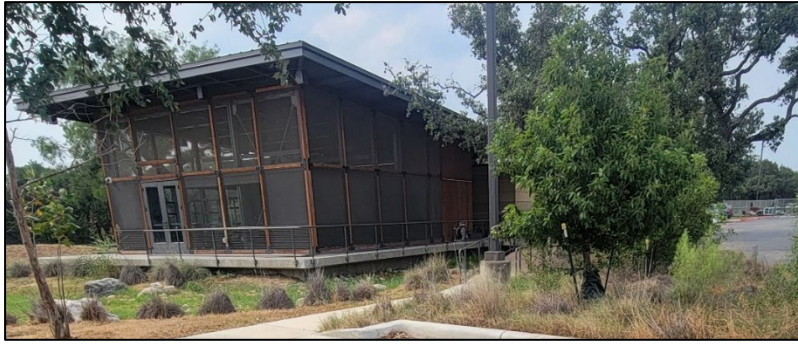
Figure 2 – The Mesquite Living Lab facility.

Objective three funded the construction and operation of the Mesquite Living Lab, a 2,000 square foot open-air classroom used to host a youth summer camp, site visits by local professional organizations, and provide research opportunities for UTSA students. The facility includes a cistern, a green roof, and a bioretention basin.

The third objective included the construction of the Mesquite Living Lab, the demonstration LID features, and a commitment to using the facility for water resources related education (see Figure 2). The cistern can hold 2,700 gallons and collects roof runoff. There is also a green roof over the restroom, and a bioretention system which captures an acre of parking lot runoff. This bioretention system was part of the monitoring effort in objective two.
